Cornerstone Home Inspections LLC

Report ID:
1162

Report #: 1162
Subject Property: [REDACTED]
 Las Vegas , NV 89117

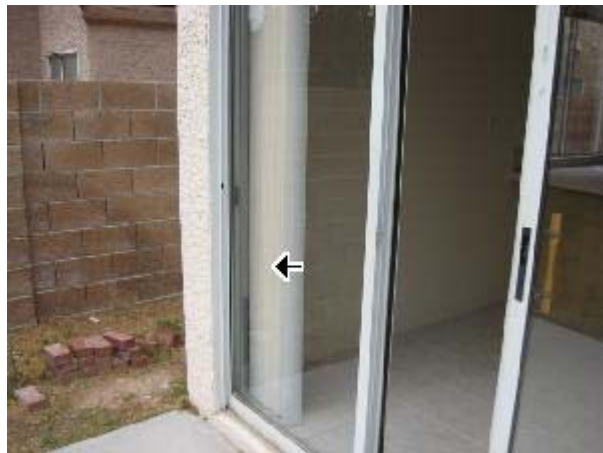
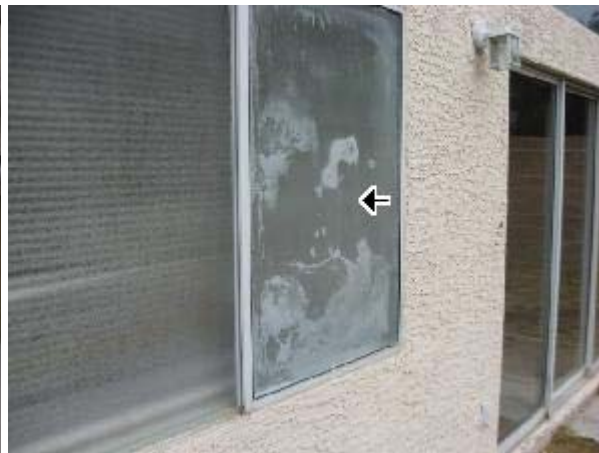
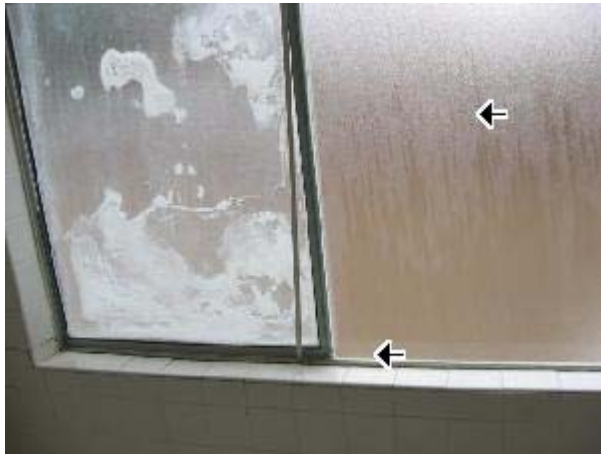
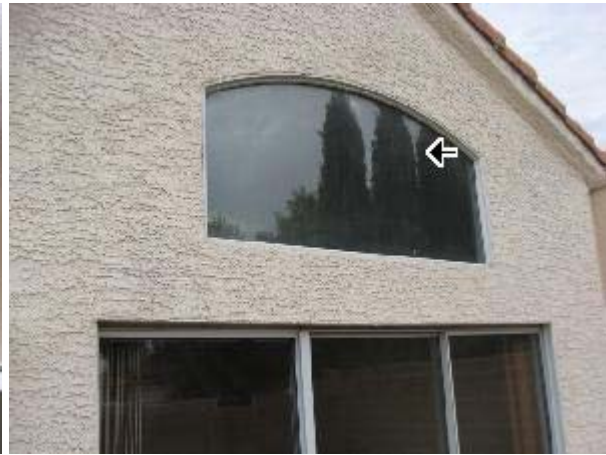
2.2 WINDOWS

Comments: Inspected, Repair or Replace

There were two rear kitchen/dining windows had broken exterior panes, the down stairs masterbath had a failed window seal thus leaving a foggy look to the window. The second privacy window adjacent to failed seal is also broken and a single pane plexi was put in place as a temp fix. It also appeared that another seal above the master bedroom may have had a bad seal as it show some signs of moisture drips in window. However it recently rained and it could be on the exterior only giving a false indication.

There were two rear kitchen/dining windows had broken exterior panes, the down stairs masterbath had a failed window seal thus leaving a foggy look to the window. The second privacy widow adjacent to failed seal is also broken and a single pane plexi was put in place as as a temp fix. It also appeared that another seal above the master bedroom may have had a bad seal as it show some signs of moisture drips in window. However it recently rained and it could be on the exterior only giving a false indication.

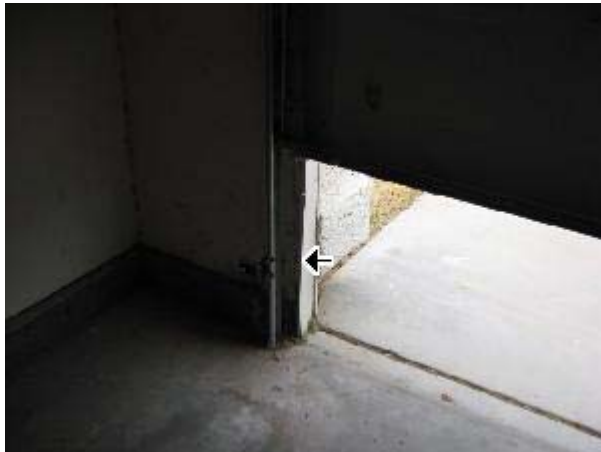
2.3 GARAGE DOOR AND (OPERATORS) (Not checked for resistance, but for safety sensors)

Comments: Inspected, Repair or Replace

The roll up garage door did not close when the button was pushed. This is usually when the sensors are not aligned properly.

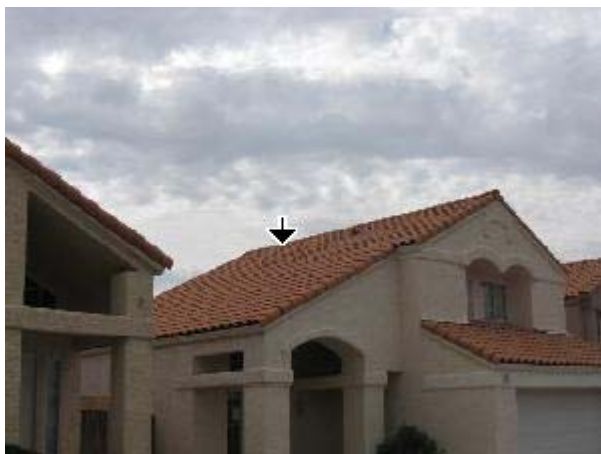
3.0 ROOF COVERINGS

Comments: Inspected, Repair or Replace

I observed some tiles that appeared to have been recently replaced as the color did not match exactly. They were on the North Field area and some of them did not look fully interlaced and or have slipped.

I observed some tiles that appeared to have been recently replaced as the color did not match exactly. They were on the North Field area and some of them did not look fully interlaced and or have slipped.

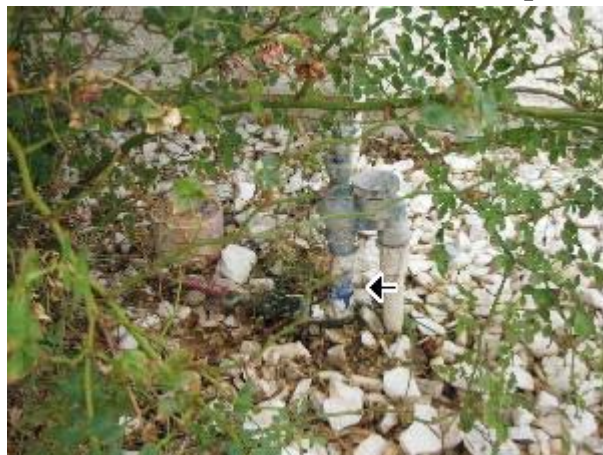
4.1 ANTI-SIPHON VALVES (For lawn sprinklers or pool fill).

Comments: Inspected, Repair or Replace

The anti-siphon valve for the sprinklers was leaking at front yard and was missing insulation.

The anti-siphon valve for the sprinklers was leaking at front yard and was missing insulation.

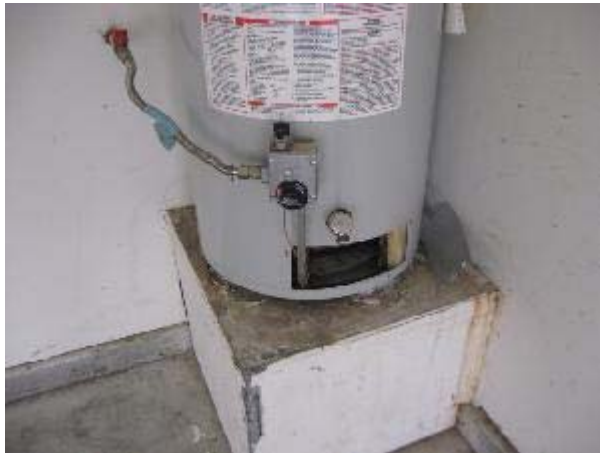
4.4 HOT WATER HEATING SYSTEMS (Water heater, Flues and Combustion air).

Comments: Inspected, Repair or Replace

The water heater was not lit at time of inspection However after several attempts I was unable to get it to light.

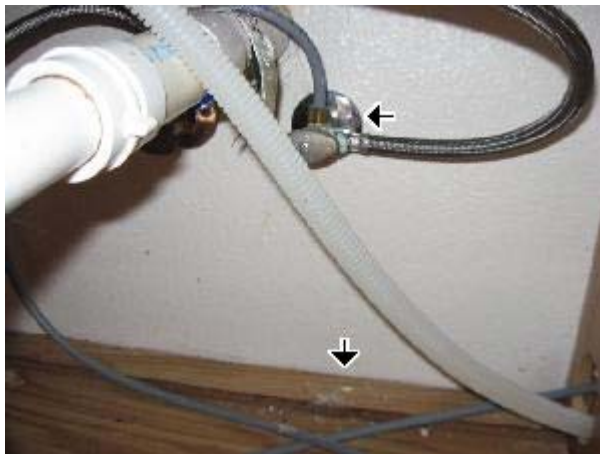
4.5 KITCHEN COMPONENTS

Comments: Inspected, Repair or Replace

There was corrosion build up on an angle stop under kitchen sink which has sealed itself leaving some past minor water damage, (stains) for info only.

There was corrosion build up on an angle stop under kitchen sink which has sealed itself leaving some past minor water damage, (stains) for info only.

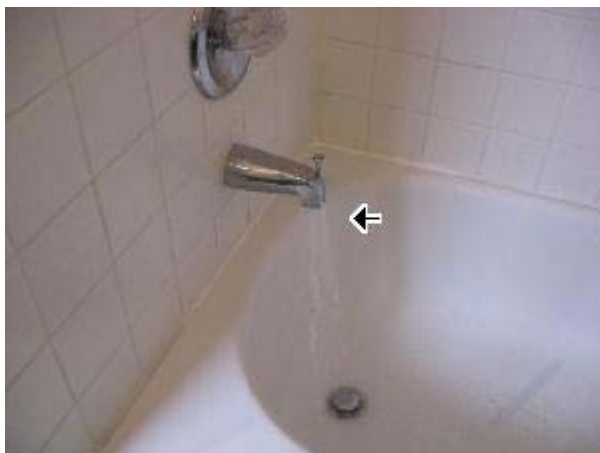
4.6 BATHROOM COMPONENTS

Comments: Inspected, Repair or Replace

Upstairs hall bath tub diverter was not fully functional when diverting to the the shower.
The sink drain was also slow draining.

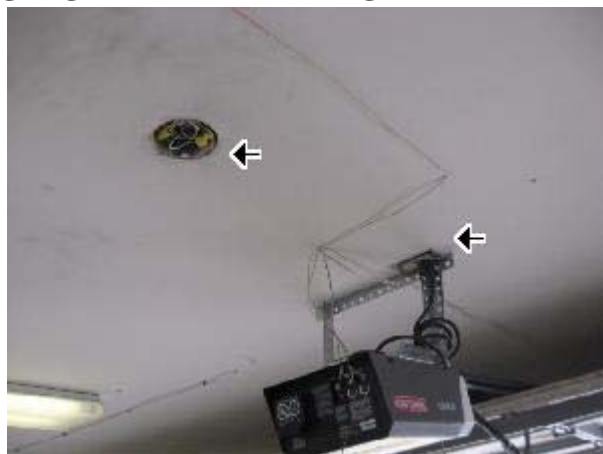
5.4 CONNECTED DEVICES AND FIXTURES (Observed from a representative number operation of ceiling fans, lighting fixtures, switches and receptacles located inside the house, garage, and on the dwelling's exterior walls)

Comments: Inspected, Repair or Replace

There were two missing cover plates observed on garage ceiling at time of inspection.

There were two missing cover plates observed on garage ceiling at time of inspection.

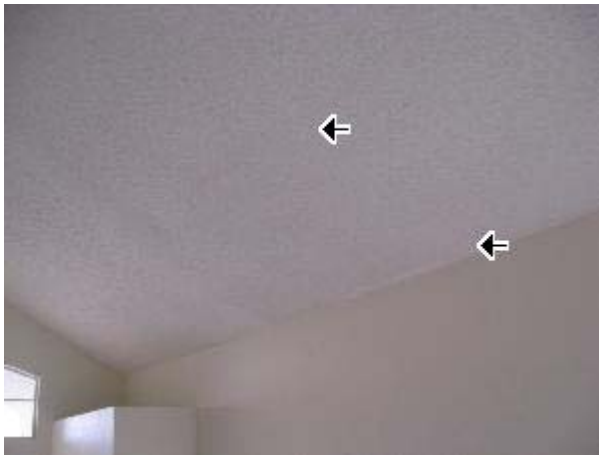
6.0 CEILINGS

Comments: Inspected, Repair or Replace

Although we had recent rains, it was difficult to say if there was a discoloration on the vaulted living room ceiling but it looked like there was a slight touch up of a sealer and a possible discoloration observed.

Although we had recent rains, it was difficult to say if there was a discoloration on the vaulted living room ceiling but it looked like there was a slight touch up of a sealer and a possible discoloration observed.

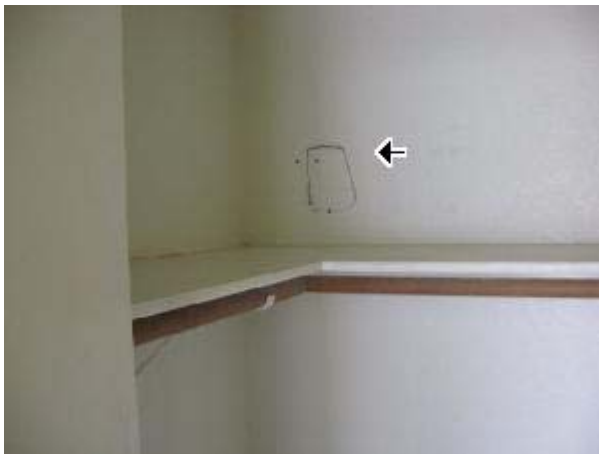
6.1 WALLS

Comments: Inspected, Repair or Replace

There was an unfinished wall repair in the master bedroom closet at time of inspection.

There was an unfinished wall repair in the master bedroom closet at time of inspection.

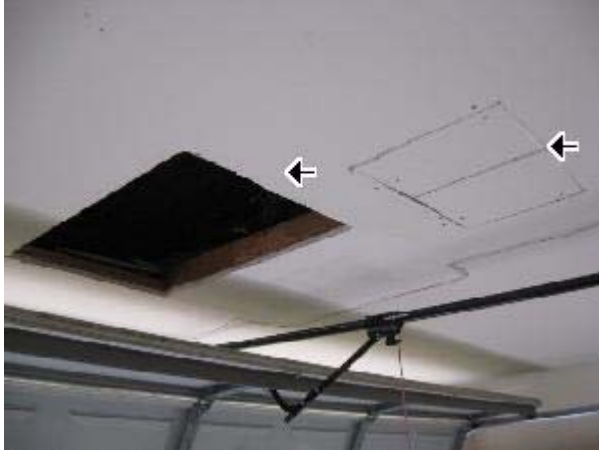
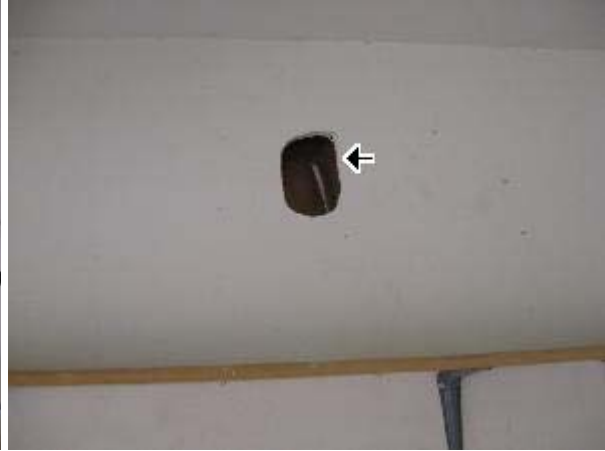
6.4 GARAGE WALLS AND CEILINGS

Comments: Inspected

There were several holes in the sheetrock of garage, this compromises the one hour fire rating.

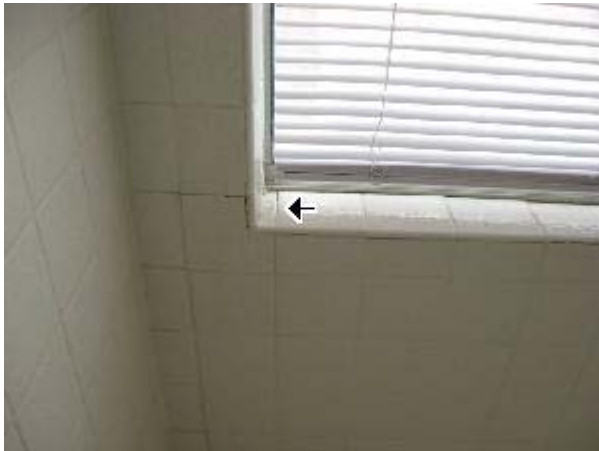
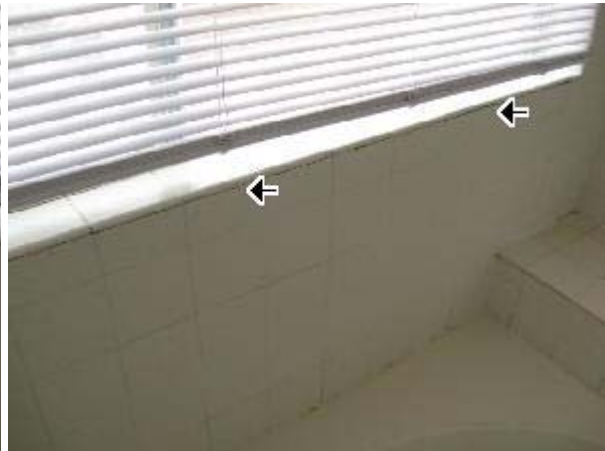
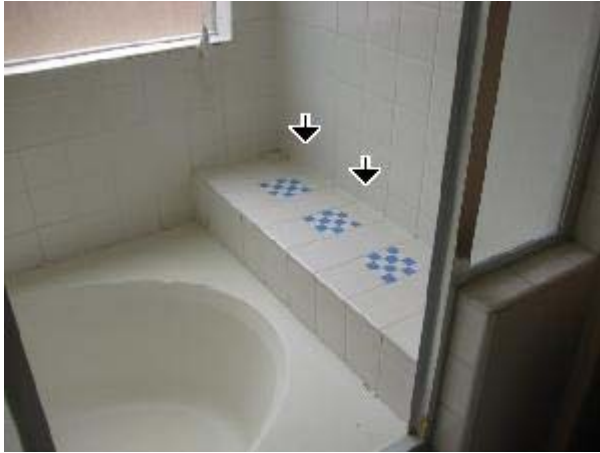
6.7 SHOWER WALLS

Comments: Inspected, Repair or Replace

The grout is coming loose near the window ledge area in the master bath shower and has a few loose tiles.

The rear landing of the tub had a backwards slope allowing water to puddle, if not properly sealed or corrected water will get trapped and damage will occur underneath.

The grout is coming loose near the window ledge area in the master bath shower and has a few loose tiles.

The rear landing of the tub had a backwards slope allowing water to puddle, if not properly sealed or corrected water will get trapped and damage will occur underneath.

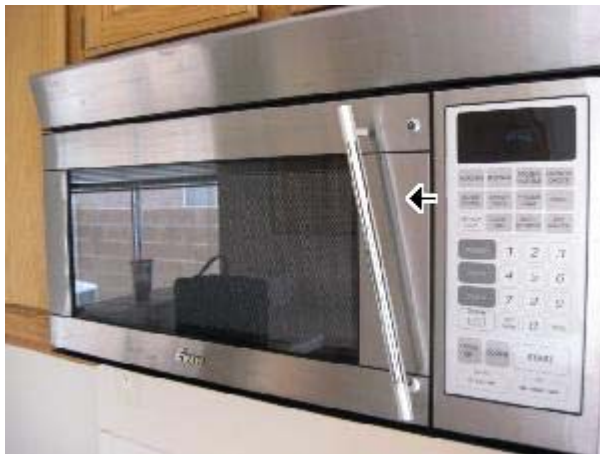
7.3 MICROWAVE COOKING EQUIPMENT

Comments: Inspected, Repair or Replace

The microwave handle was broken and the touch pad was difficult to operate, it was like you had to push very hard to make contact to operate.

The microwave handle was broken and the touch pad was difficult to operate, it was like you had to push very hard to make contact to operate.

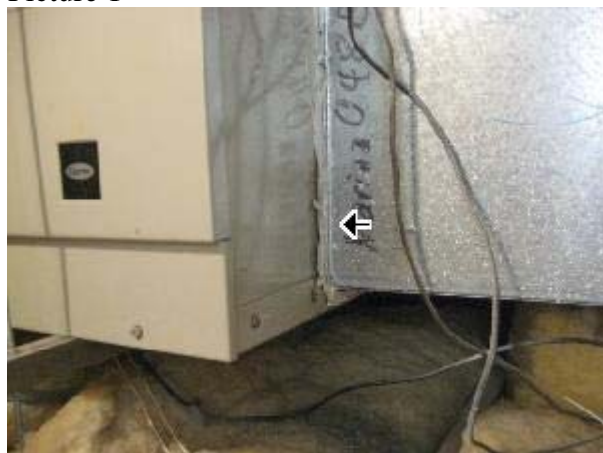
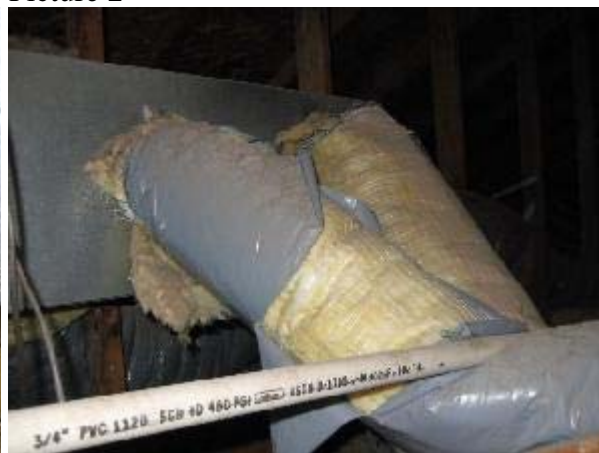
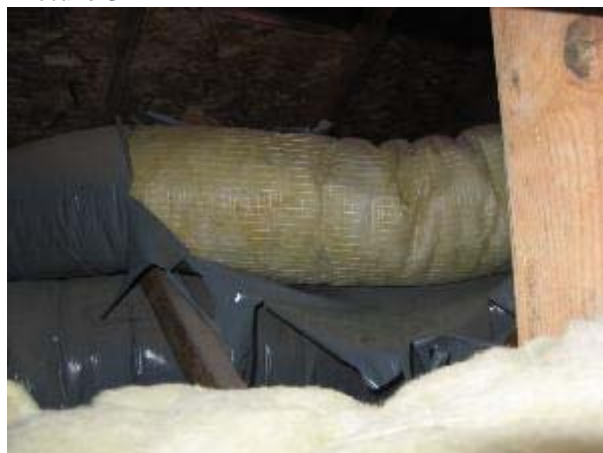
9.0 COOLING AND AIR HANDLER EQUIPMENT

Comments: Inspected, Repair or Replace

The downstairs air handler has some voids in the sealant thus allowing air loss to the attic.

The upstairs unit has insulation on the ducts but there was an added layer of protection that was torn in several places, allowing slight loss of efficiency.

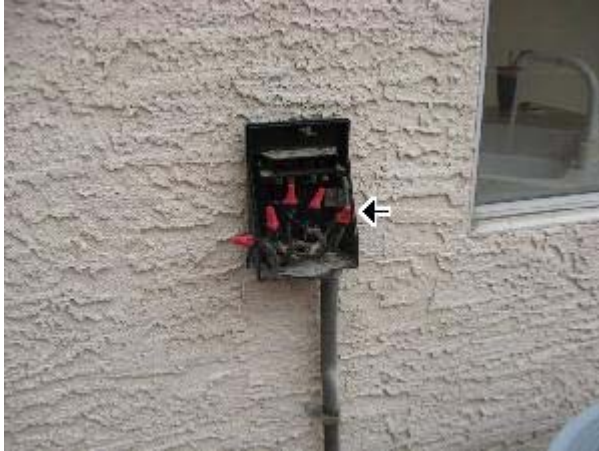
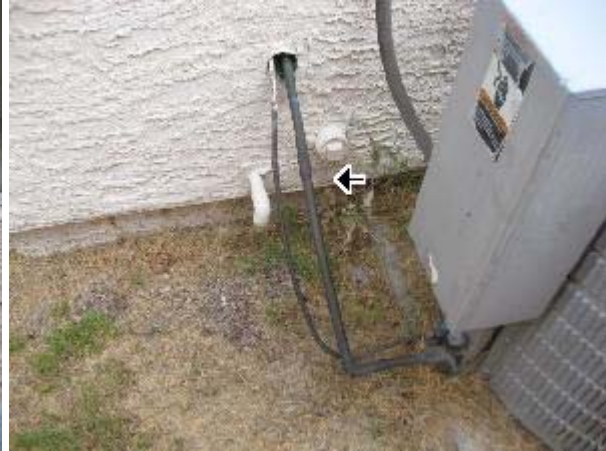
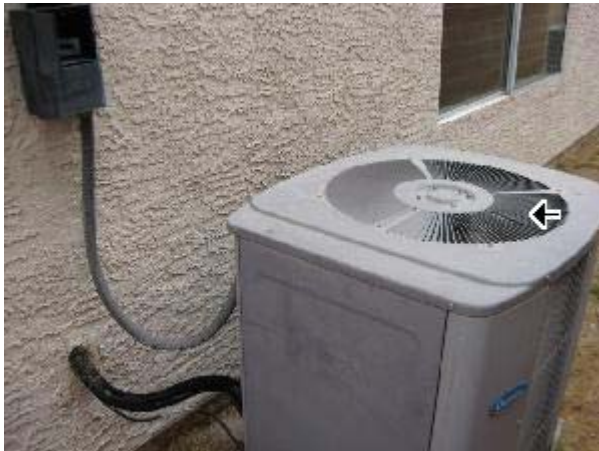
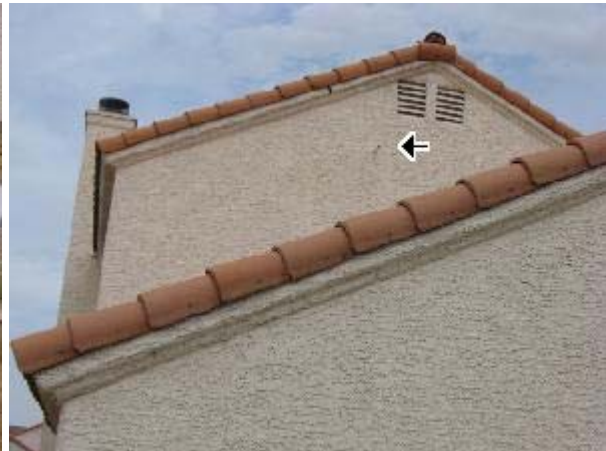
9.2 DISTRIBUTION SYSTEMS (including fans, pumps, ducts and piping, with supports, insulation, air filters, registers, radiators, fan coil units and convectors)

Comments: Inspected, Repair or Replace

Both A/C Units were inoperable.

The downstairs unit was not wired in order to run, and there was missing insulation on the suction line.

The upstairs unit outdoor condensing unit was not running.

There was a missing 90 degrees fitting on the condensate line, view over kitchen.

The downstairs unit was not wired in order to run, and there was missing insulation on the suction line.

There was a missing 90 degrees fitting on the condensate line, view over kitchen.
