Cornerstone Home Inspections

Inspected Property
9473 Borough Park St.
Las Vegas, NV 89178

Inspection Date
Thursday, August 25, 2016

Report ID:
16166

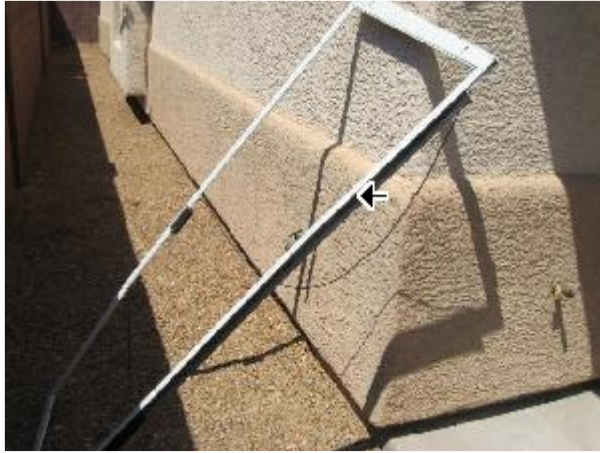
2.3 SCREENS

Comments: Inspected, Repair or Replace
The rear sliding patio screen door was damaged.

The rear sliding patio screen door was damaged.

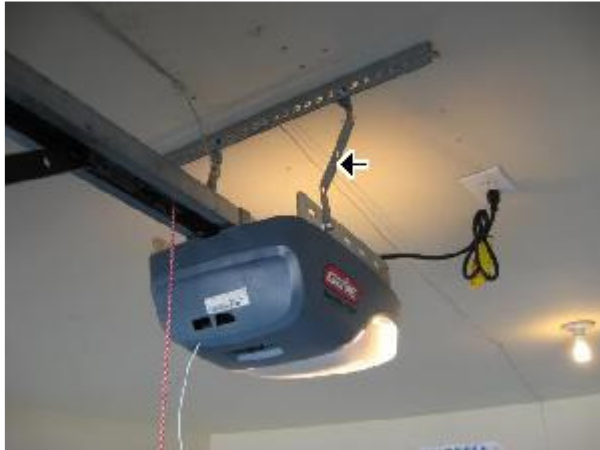
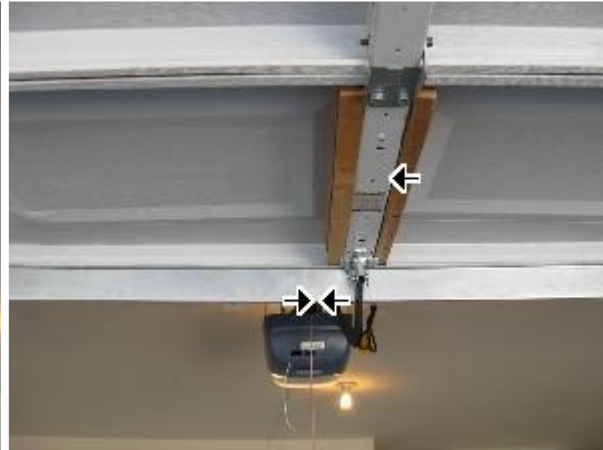
2.4 GARAGE DOOR AND (OPERATORS) (Not checked for resistance, but for safety sensors)

Comments: Inspected, Repair or Replace
The garage door opener was not square to the door, it appears to have had prior damage and some what repairs, it is not stable at this time and needs further repair.

The garage door opener was not square to the door, it appears to have had prior damage and some what repairs, it is not stable at this time and needs further repair.

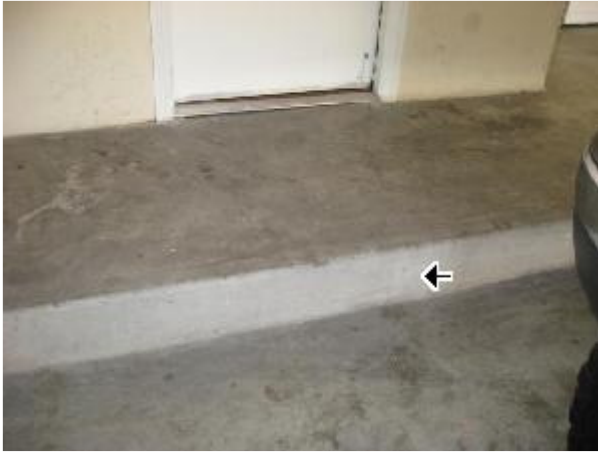
2.6 VEGETATION, GRADING, DRAINAGE, DRIVEWAYS, PATIOS, WALKWAYS AND RETAINING WALLS (With respect to their effect on the condition of the building)

There is a very high housekeeping pad in the garage that can pose as a trip hazard, although the home is built and passed building inspections it may be wise to paint a yellow line along the edge as a precaution.

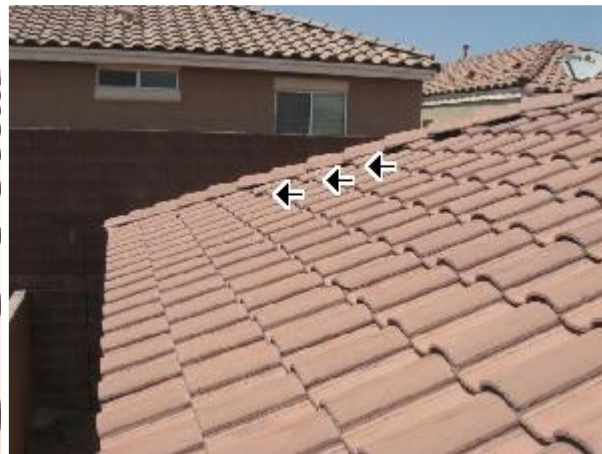
3.0 ROOF COVERINGS

Comments: Inspected, Repair or Replace
There were a few slipped /misplaced roof tiles observed over the front entry of the home.
There was also a tile or two at the rear of the home that has slipped or been misplaced.

There were a few slipped /misplaced roof tiles observed over the front entry of the home. There was also a tile or two at the rear of the home that has slipped or been misplaced.

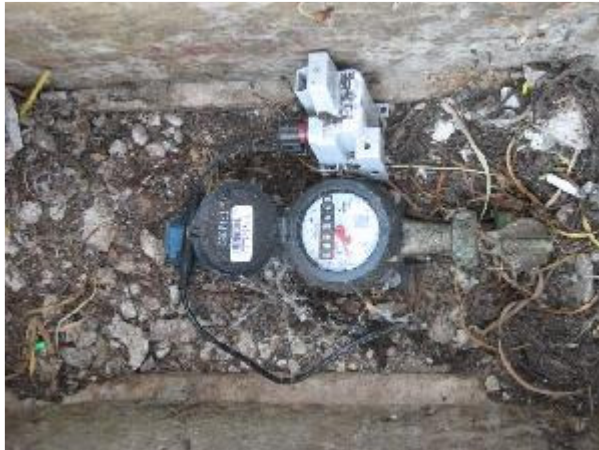
4.0 MAIN WATER SUPPLY SHUT-OFF (Located at curb area)

Comments: Inspected
View

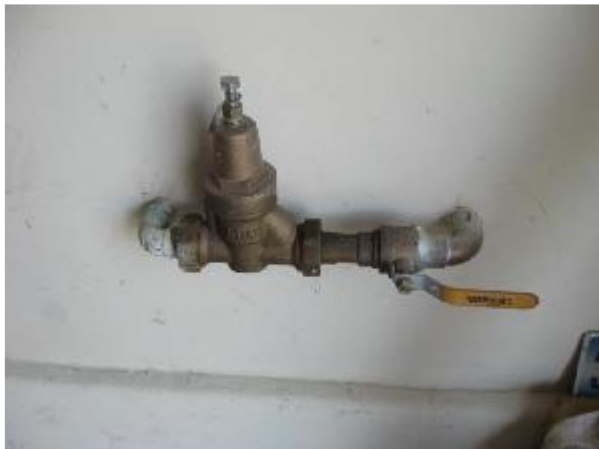
4.1 SECONDARY MAIN WATER SUPPLY SHUT OFF VALVE

There is a secondary house water shut off valve located in the garage.

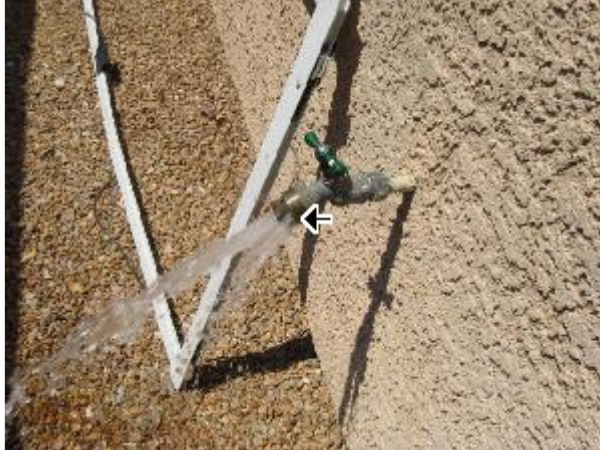
4.3 EXTERIOR HOSE FAUCETS

The back flow device installed on the rear yard hose faucet was inoperative, causing an erratic spray pattern.

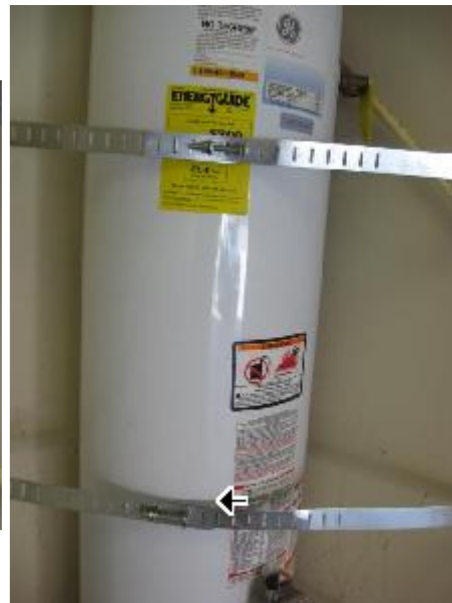
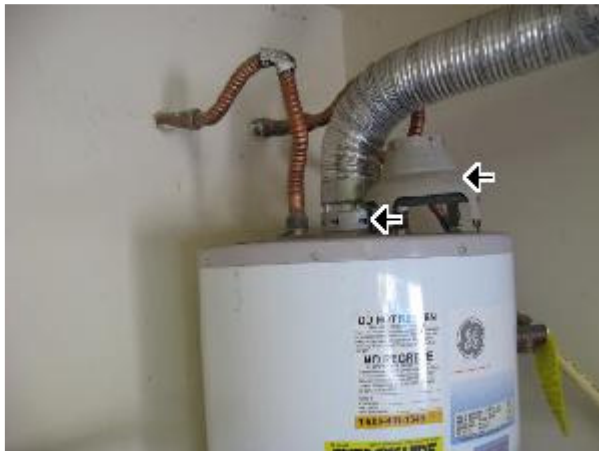
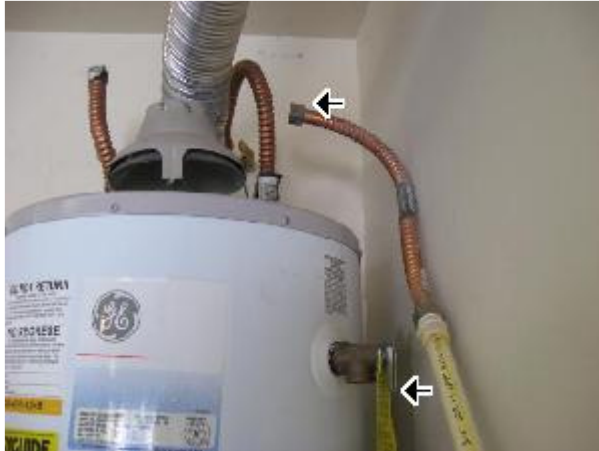
4.4 HOT WATER HEATING SYSTEMS (Water heater, Flues and Combustion air).

The flue pipe is not properly connected to the water heater.

The earthquake straps are not properly securing the water heater, the bottom one does not even touch the heater.

The T and P (temperature and pressure) relief line was not connected to the water heater.

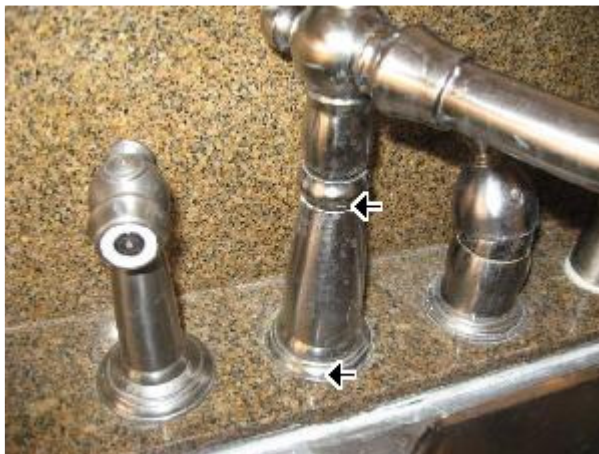
4.5 KITCHEN COMPONENTS

There was a slight drip at the kitchen faucet.

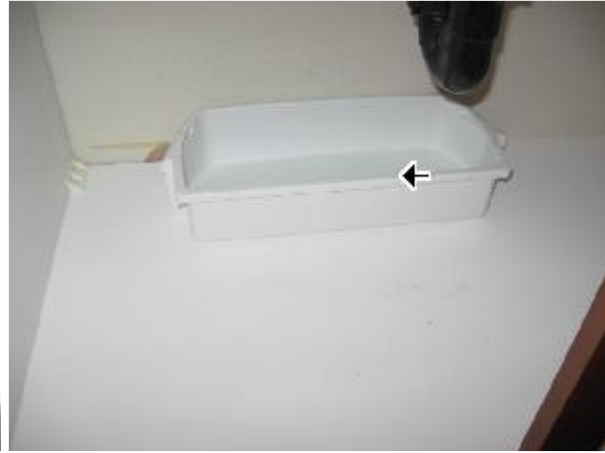
4.7 MASTER BATHROOM

There was an active drip under the left side sink of the master bathroom, hot side. I wiped up the residual water and placed a refrigerator door pan in place to catch continuing drips.

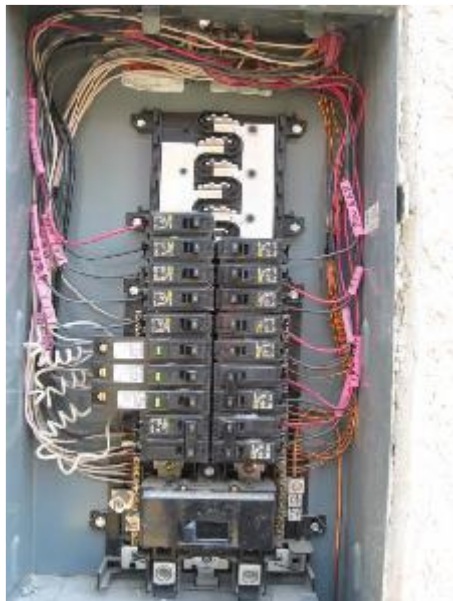
5.1 LOCATION OF DISTRIBUTION PANEL

The main electrical distribution panel is located on the exterior wall - information only.

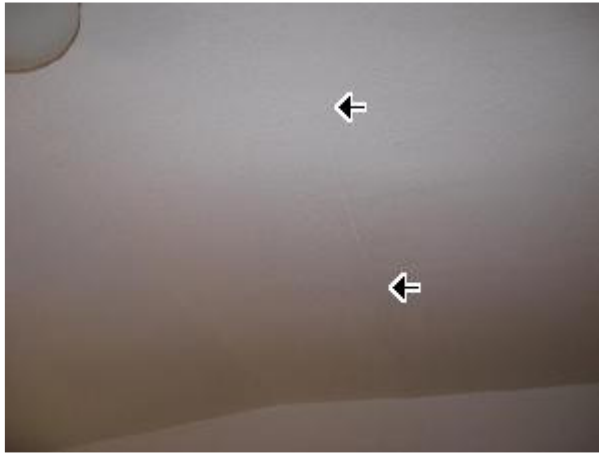
6.0 CEILINGS

Settlement cracks were observed at various areas and appear common and cosmetic in nature.

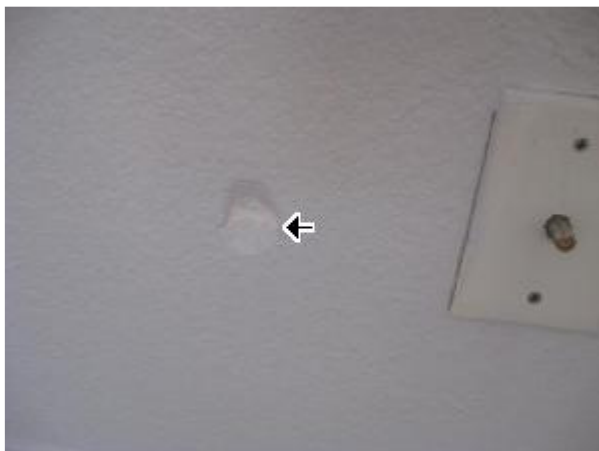
6.1 WALLS

There were 2 small holes in the 2nd bedroom wall.

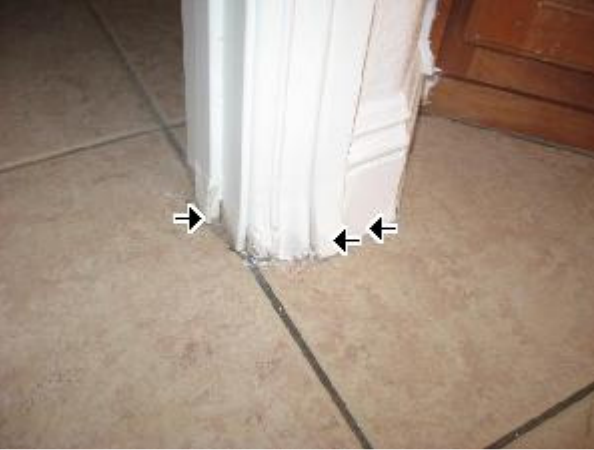
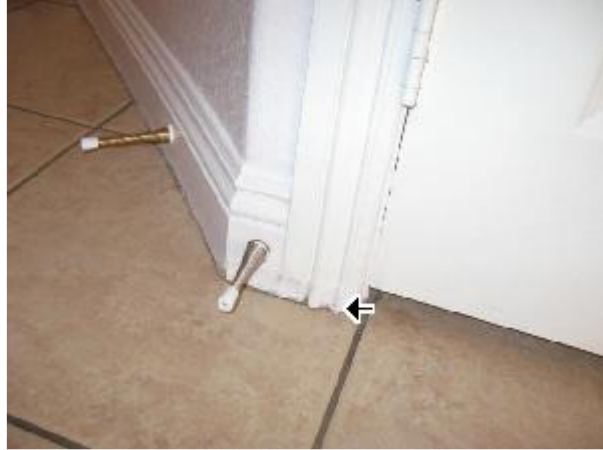
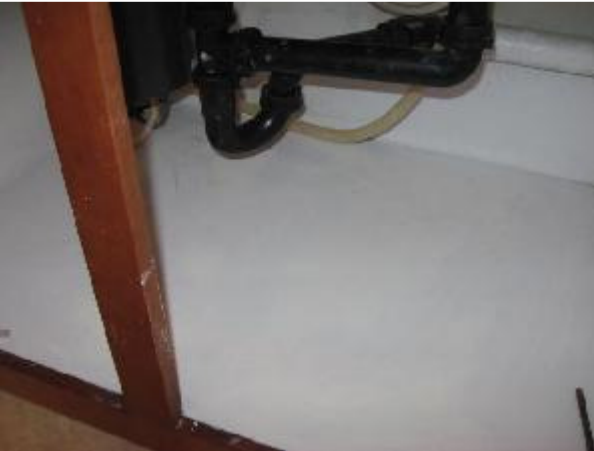
6.2 FLOORS

There were swollen baseboards observed in the kitchen areas, it appears that there may have been a past leak at one time. FYI

The underside of the kitchen cabinet has also been painted.

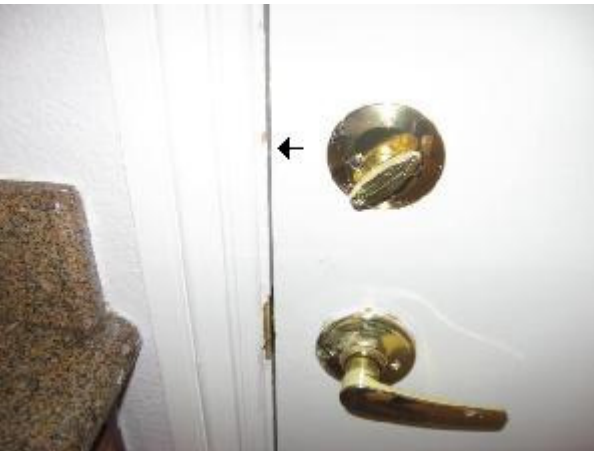
6.3 DOORS (REPRESENTATIVE NUMBER)

The dead bolt of the garage to the house door does not lock, needs adjustment.

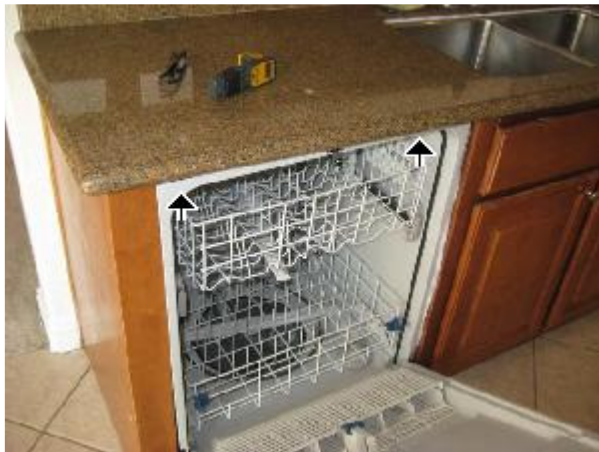
7.0 DISHWASHER

The dishwasher is not secure to the underside of the kitchen counter, (no set screws installed)

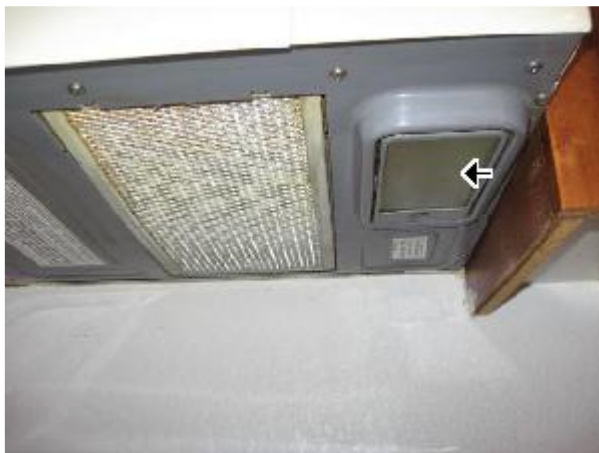
7.3 MICROWAVE COOKING EQUIPMENT

The hood lights did not operate at time of inspection.

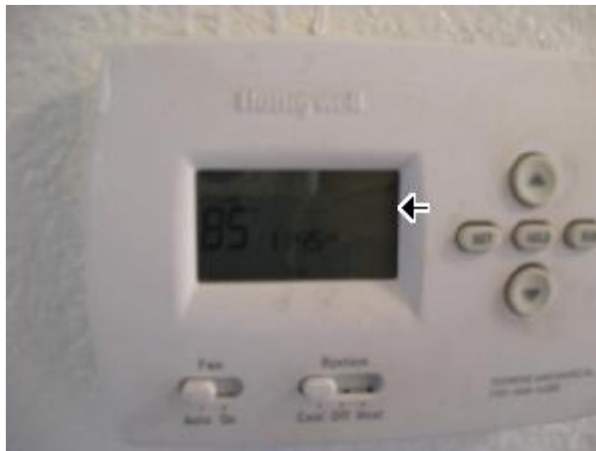
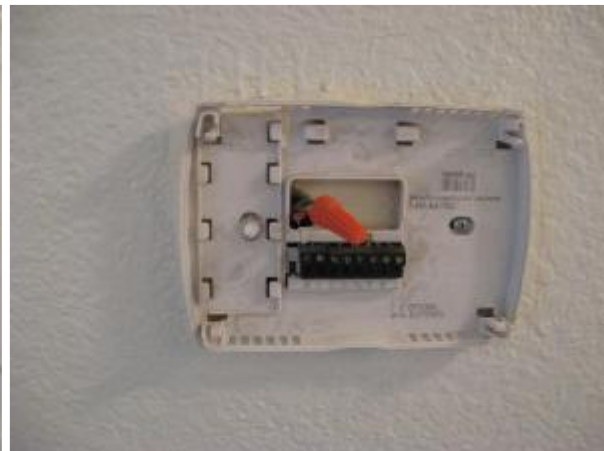
9.1 NORMAL OPERATING CONTROLS

The thermostat was not operational at time of inspection, it would not lower temperatures or turn on indoor blower.

It was jumped to test a/c operation and then re-installed.

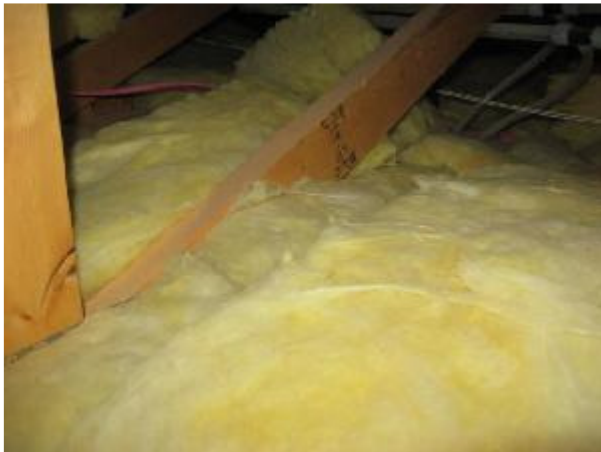
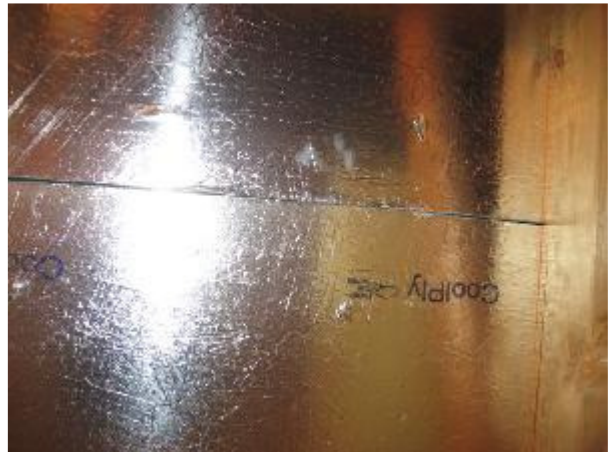
10.0 INSULATION AND VAPOR RETARDERS (in unfinished spaces)

Comments: Inspected
Views of attic insulation.
