Inspected Property
500 Feliz Contado Ct.
Henderson, NV 89015

Report ID:
17035

SCOPE OF INSPECTION

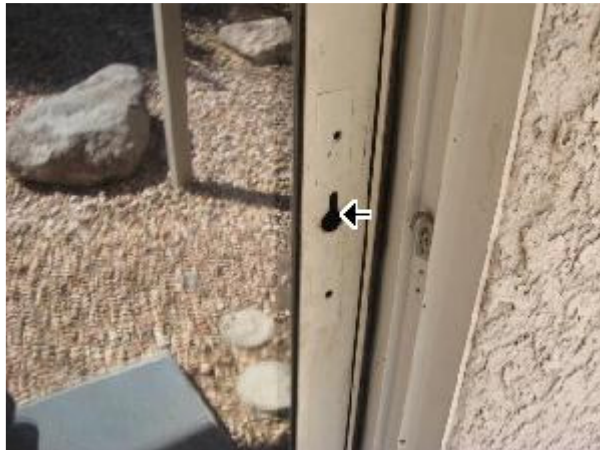
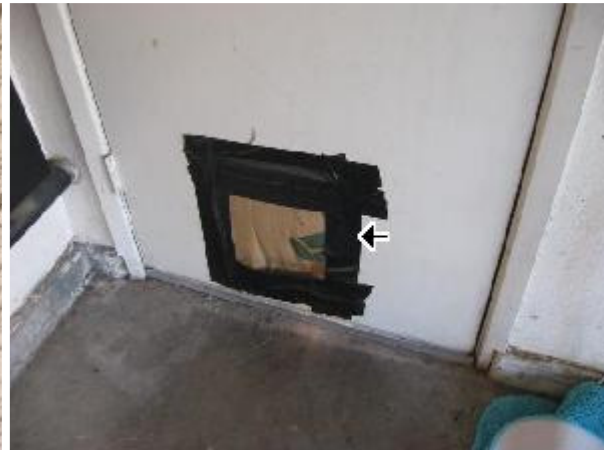
2.1 DOORS (Exterior)

Comments: Inspected, Repair or Replace
The door handle was missing to the rear yard patio door.
There was an opening in the garage to the side yard pass through door.

The door handle was missing to the rear yard patio door.

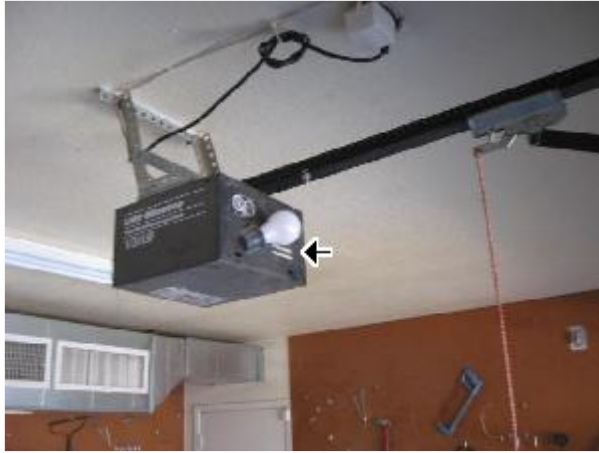
2.3 GARAGE DOOR AND (OPERATORS) (Not checked for resistance, but for safety sensors)

Comments: Inspected, Repair or Replace

Seller stated that the garage door opener worked intermittently, so it was not tested.

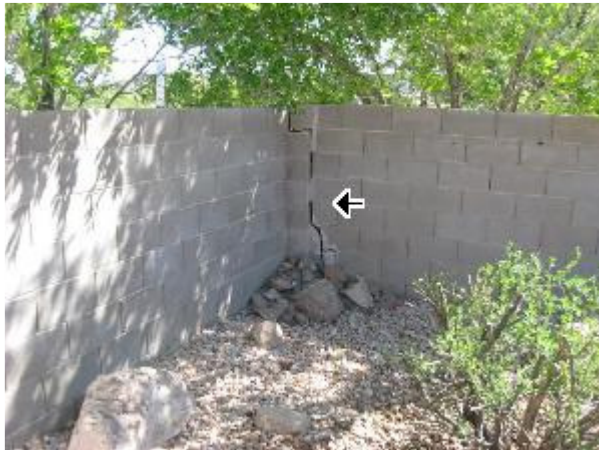
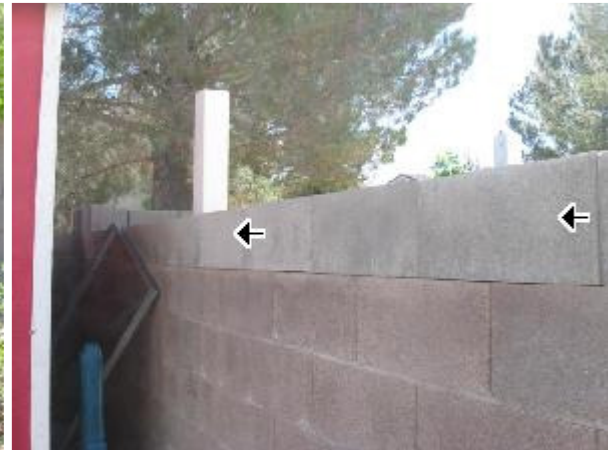
2.5 FENCING (Block Walls, Chain Link, Wrought Iron, PVC, Wood)

There was some damaged block wall observed at rear yard.

There were also bricks laid in place for privacy but were not grouted at the South side of the rear yard.

There was some damaged block wall observed at rear yard.

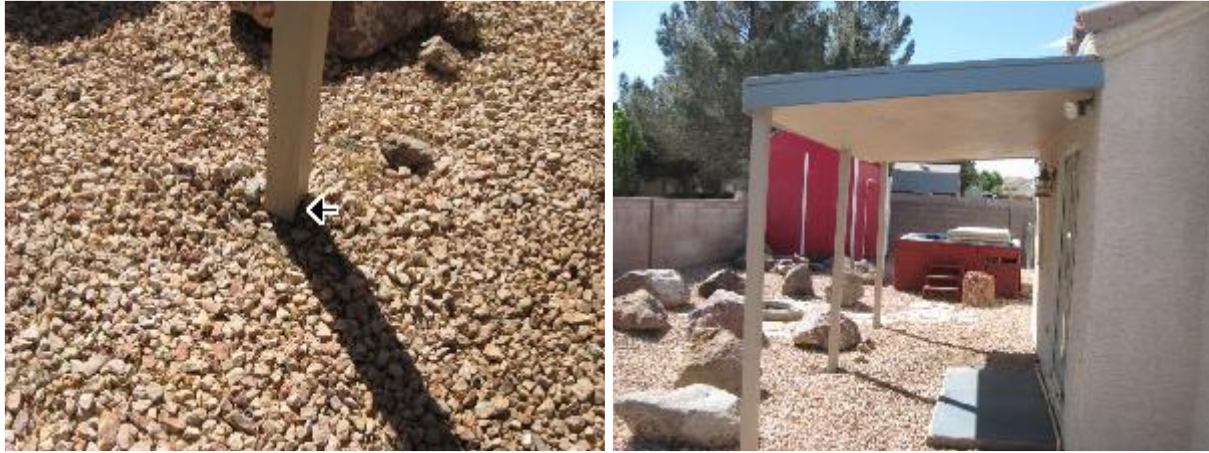
2.8 PATIO COVERINGS

The rear yard patio cover did not appear to be professionally built, there was also earth to wood contact from the support poles.

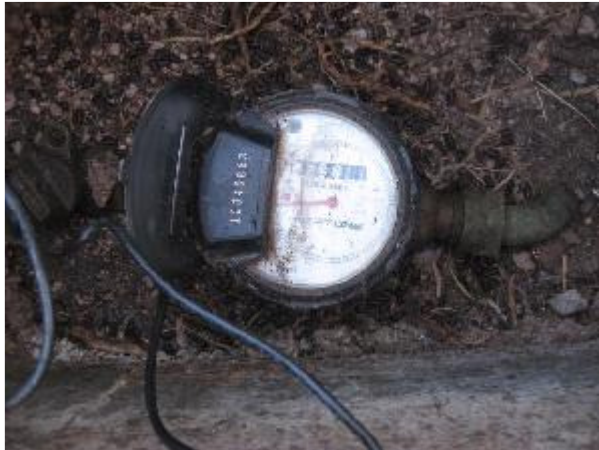
4.0 MAIN WATER SUPPLY SHUT-OFF (Located at curb area)

Comments: Inspected
View

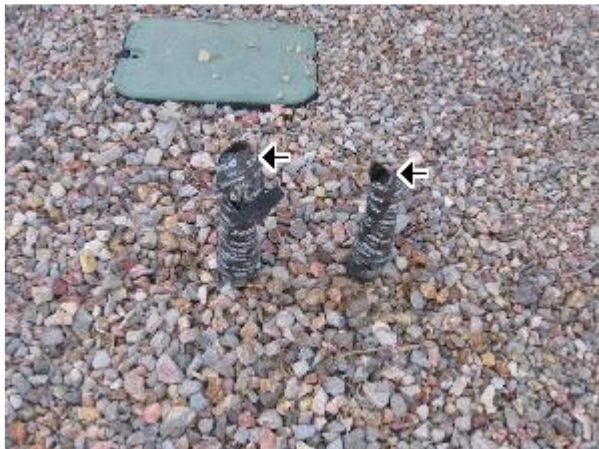
4.1 ANTI-SIPHON VALVES (For lawn sprinklers or pool fill).

Comments: Inspected, Repair or Replace
The anti-siphon valve was missing to the front yard sprinkler system.

- 4.1 **ANTI-SIPHON VALVES (For lawn sprinklers or pool fill).**
Inspected, Repair or Replace
The anti-siphon valve was missing to the front yard sprinkler system.

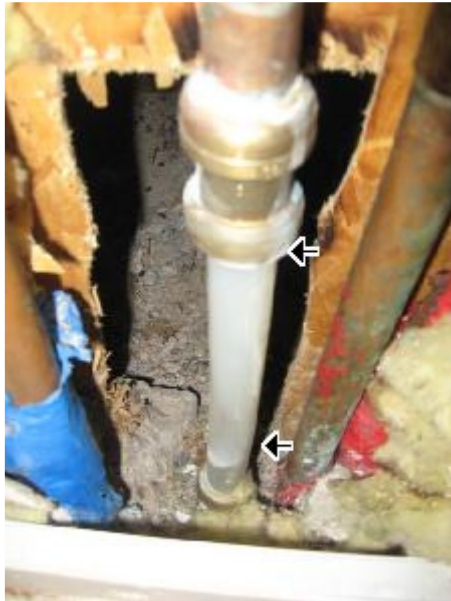
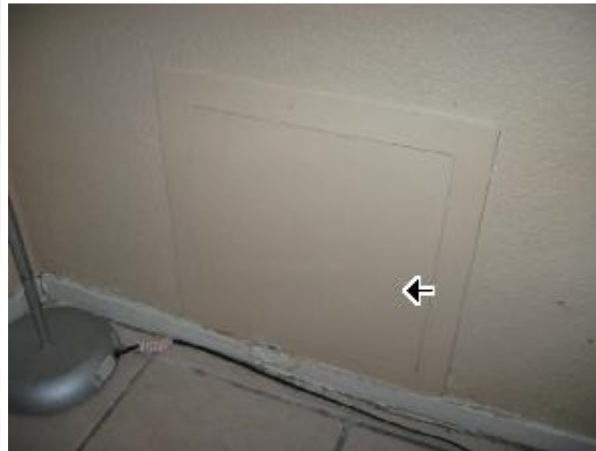
4.4 INTERIOR WATER SUPPLY AND DISTRIBUTION SYSTEMS AND FIXTURES

Comments: Inspected
There was a past repair in the main water supply observed at the back side of the water heater pedestal from the bedroom/den side of an access panel.

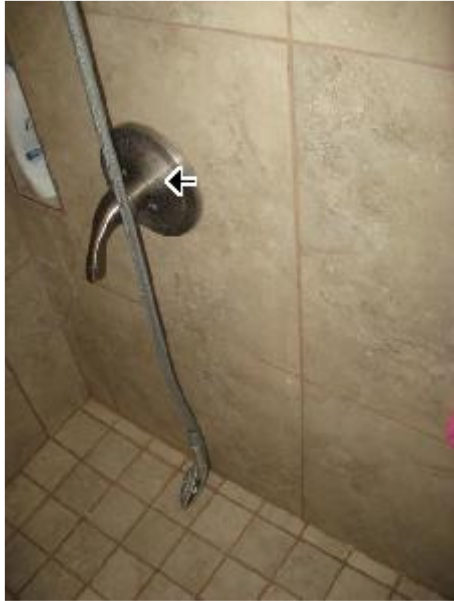
4.7 MASTER BATHROOM

Comments: Inspected, Repair or Replace
Hot and cold are reversed in the shower location.
Left side sink was slow draining.

- 4.7 **MASTER BATHROOM**
Inspected, Repair or Replace
Hot and cold are reversed in the shower location.
Left side sink was slow draining.

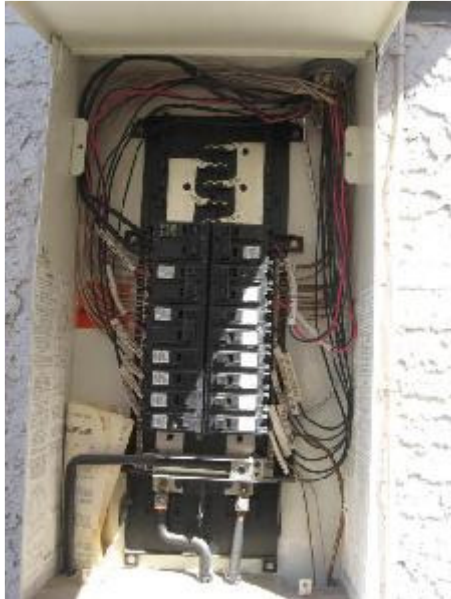
5.1 LOCATION OF DISTRIBUTION PANEL

The main electrical distribution panel is located on the exterior wall - information only.

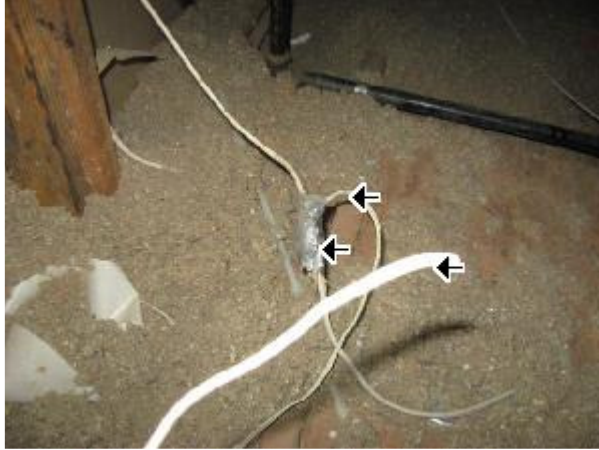
5.5 CONNECTED DEVICES AND FIXTURES (Observed from a representative number operation of ceiling fans, lighting fixtures, switches and receptacles located inside the house, garage, and on the dwelling's exterior walls)

There is an improper wire splice in attic that has a live wire that is not connected to anything. This is a live wire and needs to be addressed for safety.

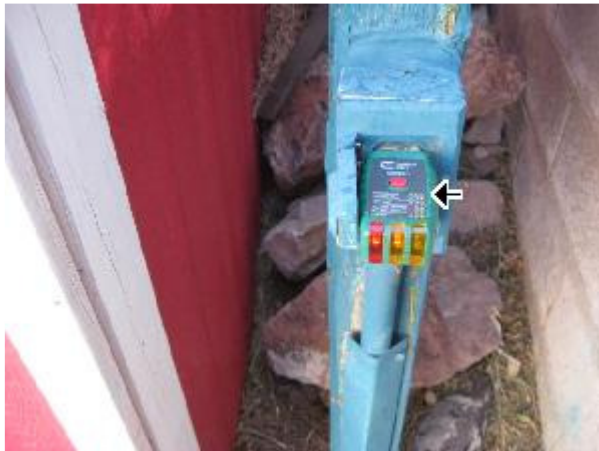
5.7 OPERATION OF GFCI (GROUND FAULT CIRCUIT INTERRUPTERS)

Outlet at rear yard next to the shed is wired improperly.

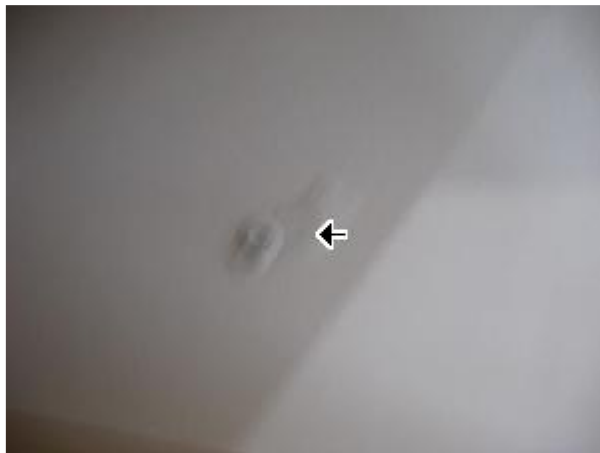
6.1 CEILINGS

There was an imperfection on the hallway ceiling next to a recessed light fixture

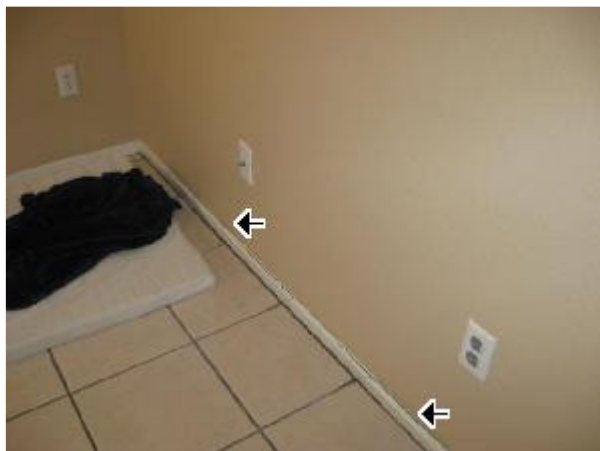
6.2 WALLS

There were swollen baseboards observed at the bedroom adjacent to the laundry room.
The seller stated that the washiness machine overflowed in the past.

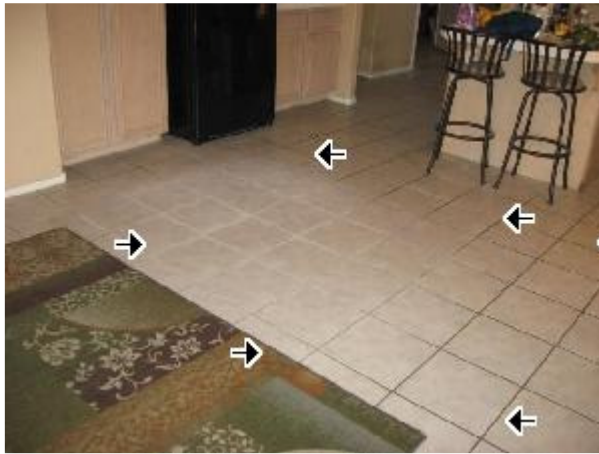
6.3 FLOORS

Comments: Inspected, Repair or Replace
There was a large area of loose and lifting and broken floor tiles in the kitchen dining family location.

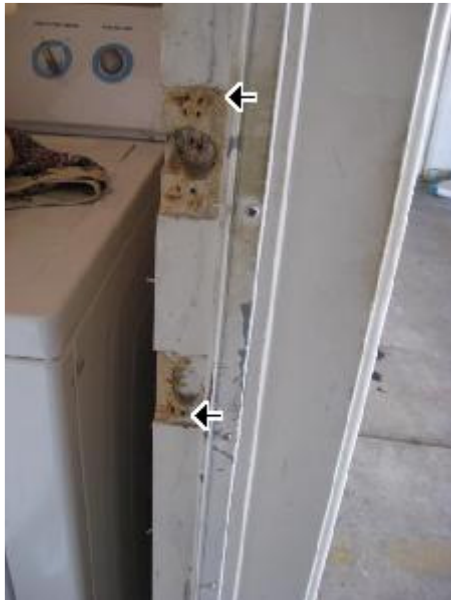
6.4 DOORS (REPRESENTATIVE NUMBER)

Comments: Inspected, Repair or Replace
The door jamb from the garage to the house in the laundry room is damaged.
The master bathroom toilet room door does not properly latch.

The door jamb from the garage to the house in the laundry room is damaged.
The master bathroom toilet room door does not properly latch.

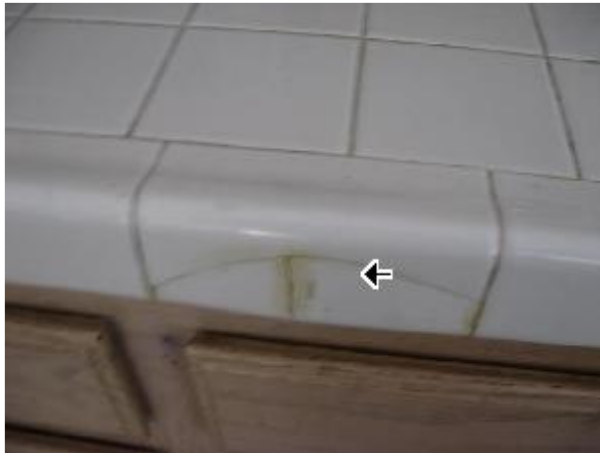
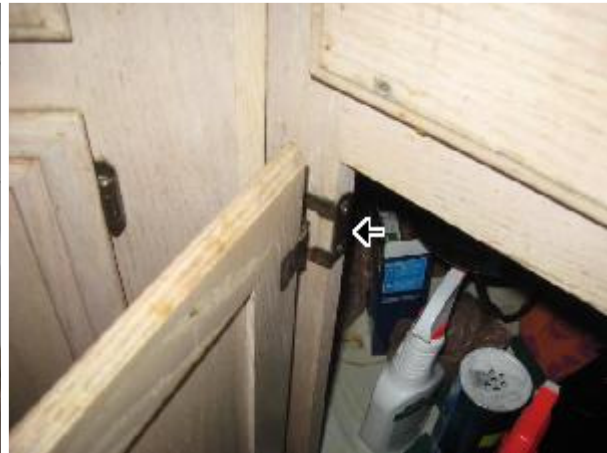
6.6 COUNTERS AND A REPRESENTATIVE NUMBER OF CABINETS

Comments: Inspected, Repair or Replace
There were several cracked kitchen counter top tiles.
There was a loose cabinet door hinge under the sink location.
There was a damaged cabinet door that has been somewhat repaired.

There were several cracked kitchen counter top tiles.
There was a loose cabinet door hinge under the sink location.
There was a damaged cabinet door that has been somewhat repaired.

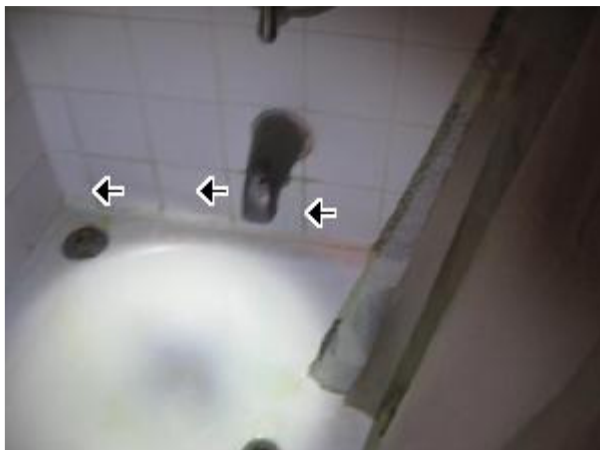
6.7 BATHROOMS

There were several loose wall tiles in the hall bath tub surround location, unable to determine the damage behind these loose wall tiles.

There was a broken medicine cabinet mirrored door.

There were several loose wall tiles in the hall bath tub surround location, unable to determine the damage behind these loose wall tiles.
There was a broken medicine cabinet mirrored door.

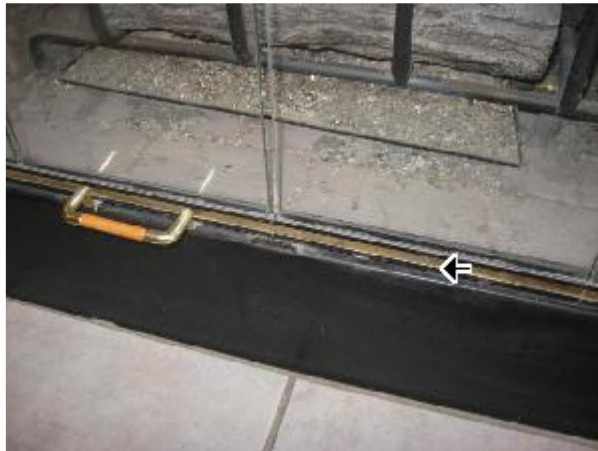
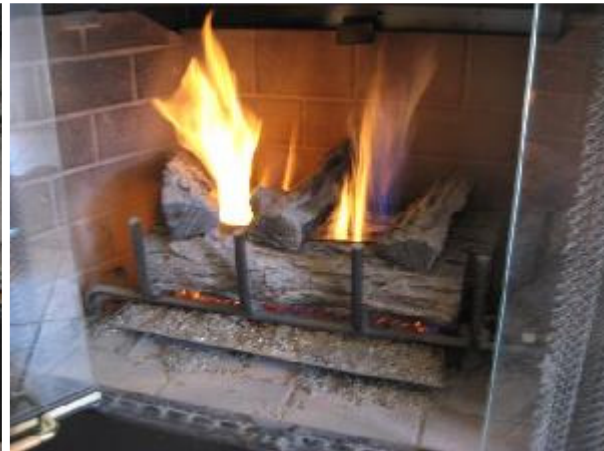
8.4 GAS/LP FIRELOGS AND FIREPLACES

Comments: Inspected, Repair or Replace
There was a missing handle for the glass doors of the fireplace.

There was a missing handle for the glass doors of the fireplace.

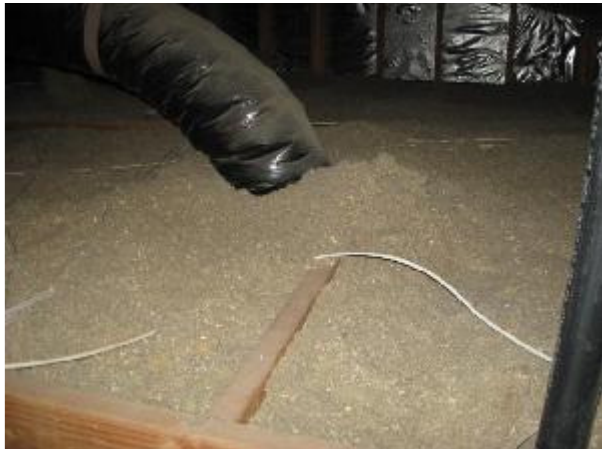
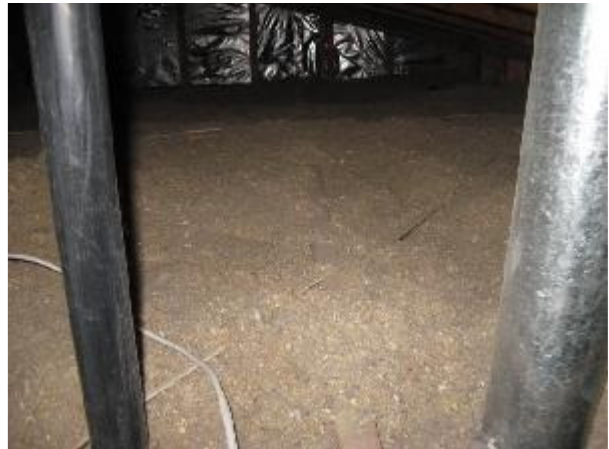
10.0 INSULATION AND VAPOR RETARDERS (in unfinished spaces)

Comments: Inspected
Views of attic insulation.
